## DOCKING REPORT

| <b>VESSEL NAME</b> | <b>M/S FRAM</b> |
| <b>INSPECTION TYPE</b> | <b>5 years, renewal inspection</b> |
| <b>DOCKING DURATION</b> | <b>6.5.2016 – 10.6.2016</b> |

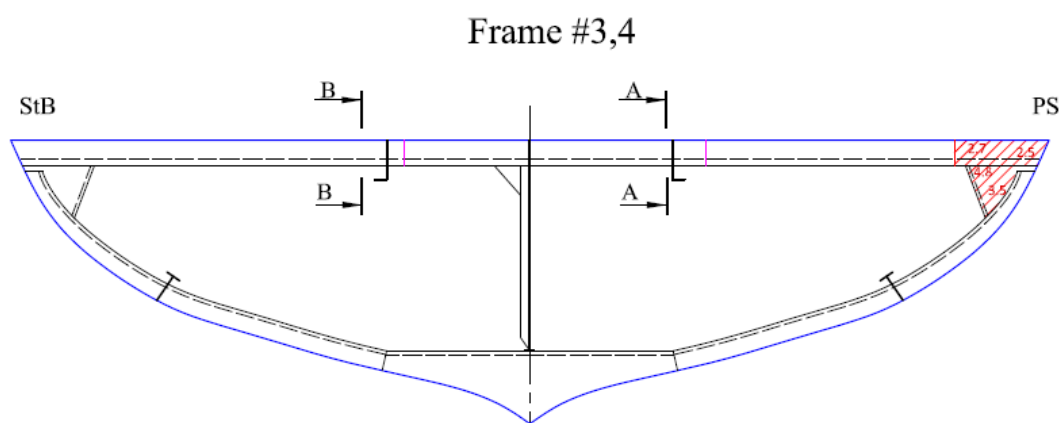
Drawing 1: *Frames 3 and 4 new brackets*

Aft peak tank were repaired at frames #2,#3 and #4. See Drawing 1 and 2.

| ITEM | CURRENT STATUS | REMARKS | DATE | AUTH |
|---|---|---|---|---|
| AFT PEAK TANK | good | Tank washed and inspected. some repairs done. | 9.6.2016 | TH |
